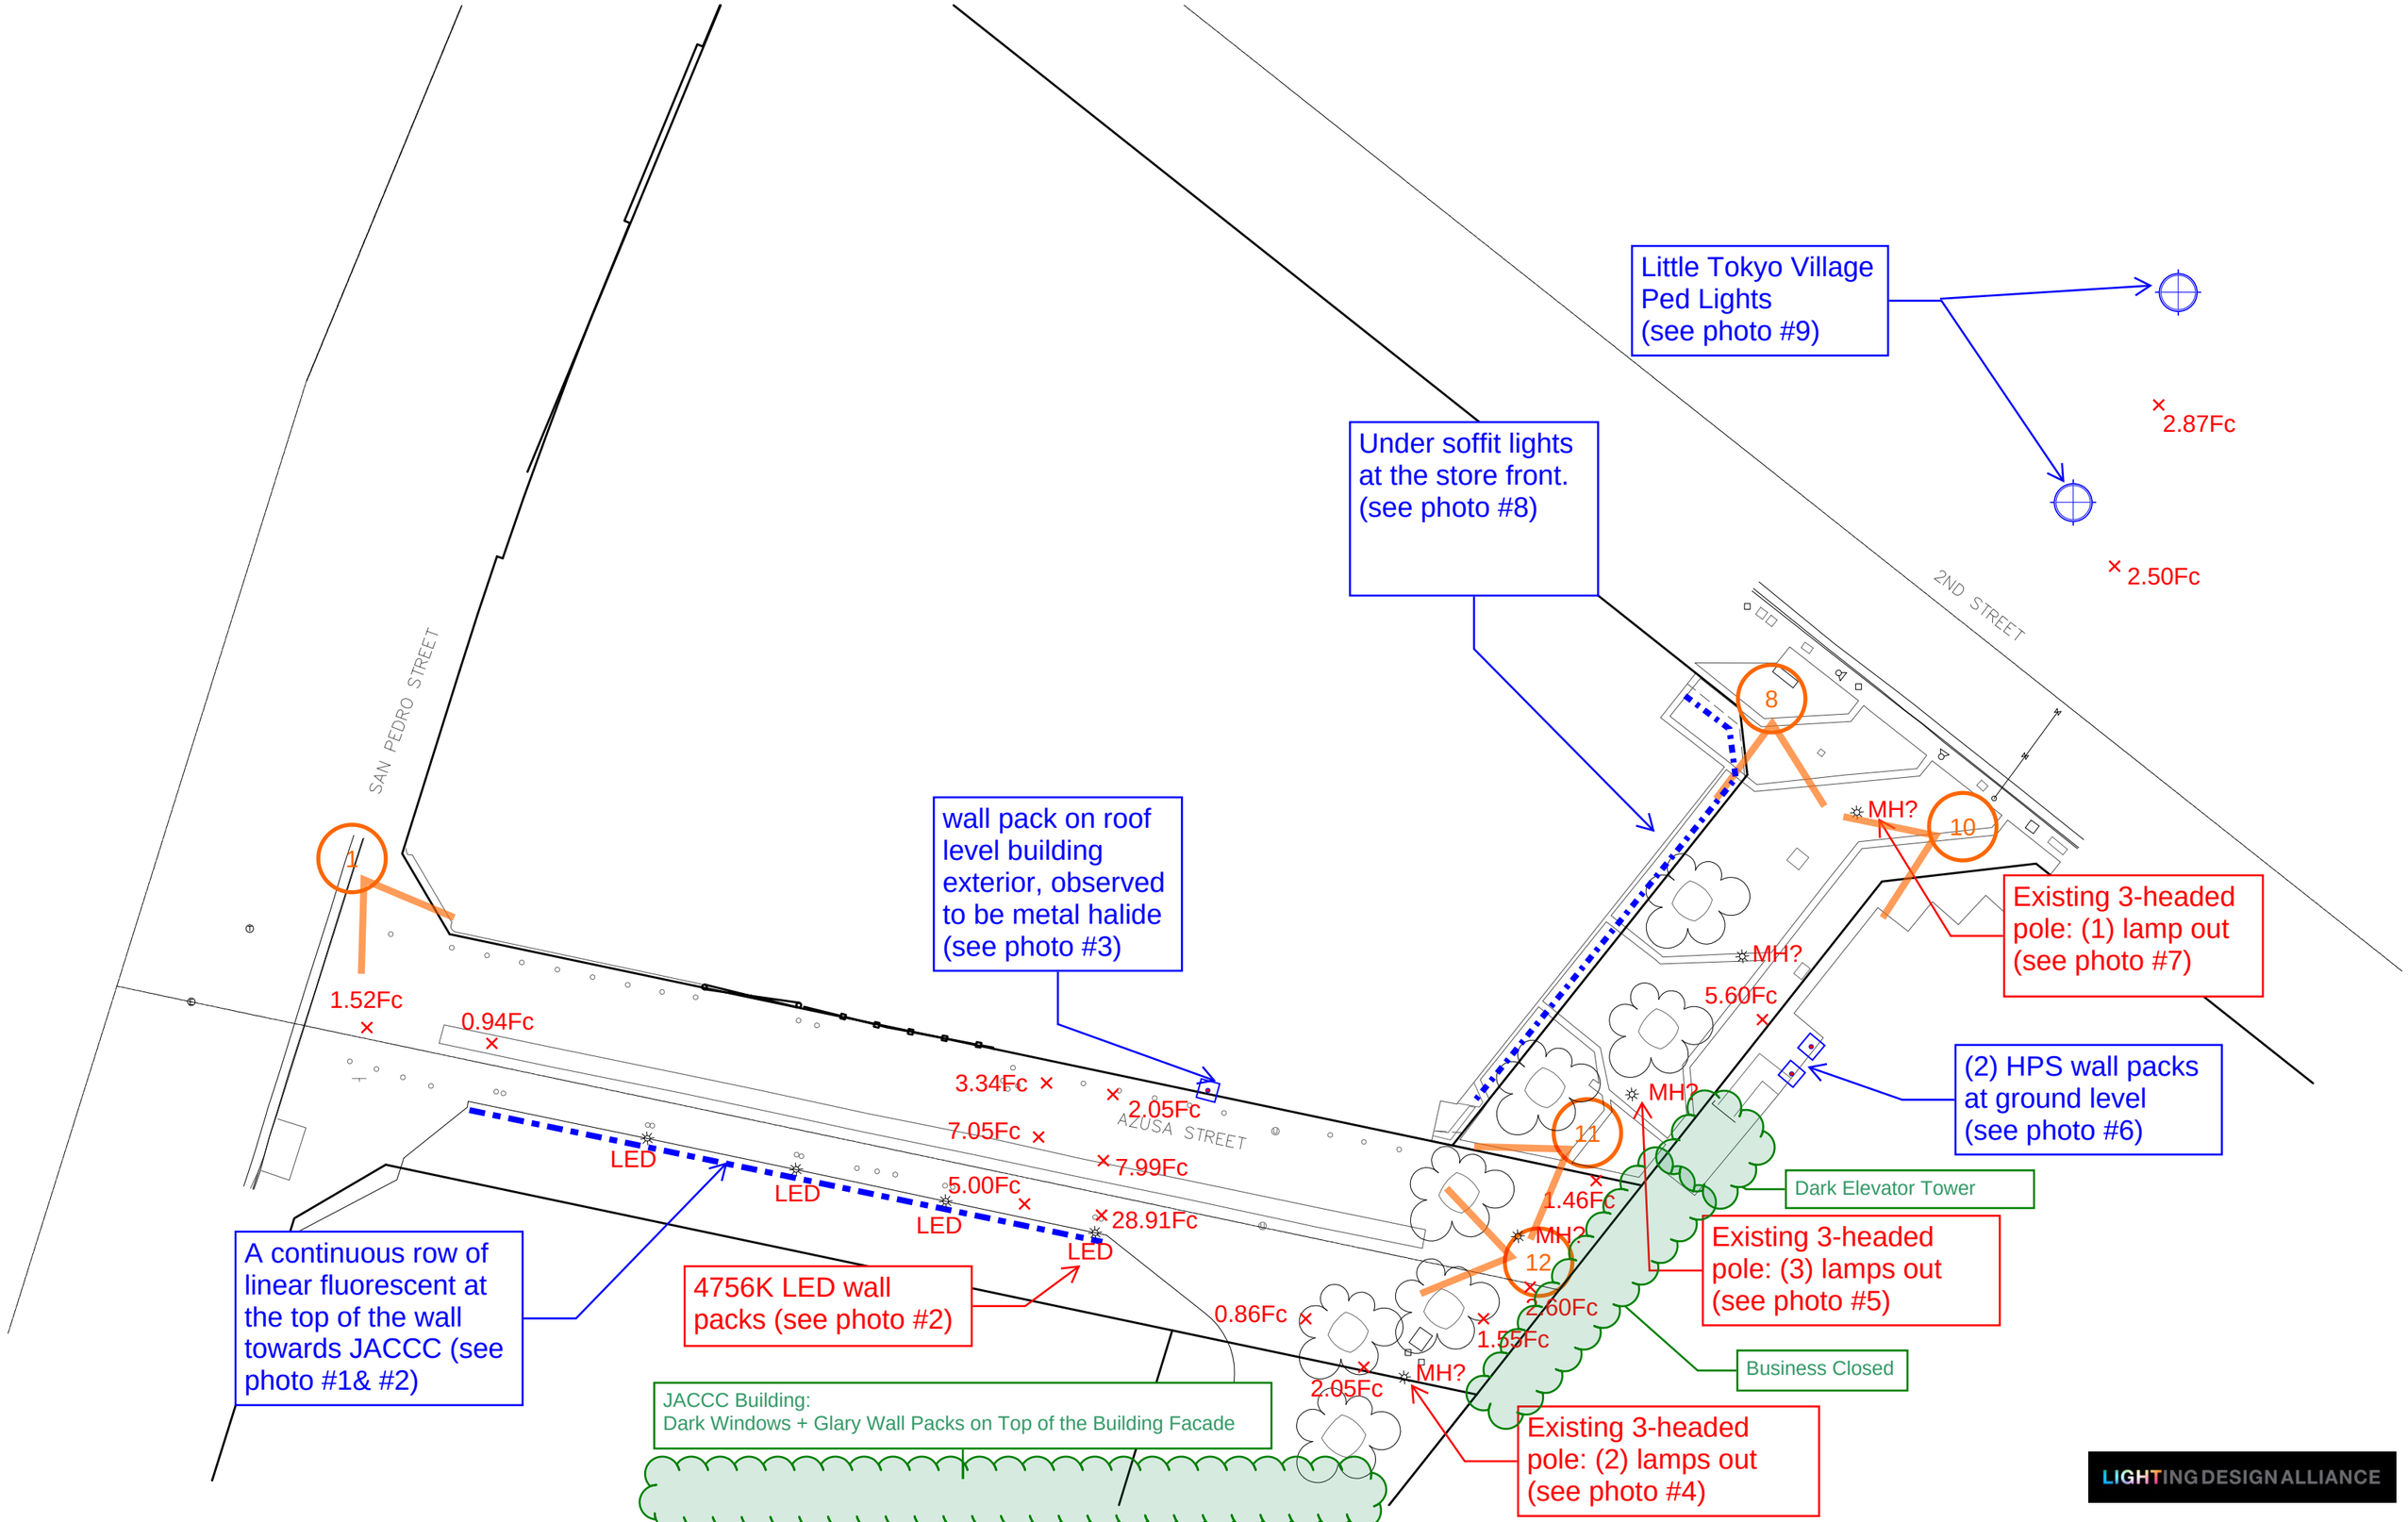
Little Tokyo Village Ped Lights (see photo #9)
2.87Fc
2.50Fc
Under soffit lights at the store front. (see photo #8)
2ND STREET
SAN PEDRO STREET
AZUSA STREET
8
10
11
12
1
MH?
Existing 3-headed pole: (1) lamp out (see photo #7)
wall pack on roof level building exterior, observed to be metal halide (see photo #3)
1.52Fc
0.94Fc
3.34Fc
2.05Fc
7.05Fc
7.99Fc
5.00Fc
28.91Fc
LED
5.60Fc
(2) HPS wall packs at ground level (see photo #6)
Dark Elevator Tower
1.46Fc
Existing 3-headed pole: (3) lamps out (see photo #5)
2.60Fc
1.55Fc
0.86Fc
2.05Fc
Business Closed
A continuous row of linear fluorescent at the top of the wall towards JACCC (see photo #1& #2)
4756K LED wall packs (see photo #2)
JACCC Building:
Dark Windows + Glary Wall Packs on Top of the Building Facade
Existing 3-headed pole: (2) lamps out (see photo #4)
LIGHTING DESIGN ALLIANCE
